Audax Engineering

Improved Army Exhaust Brake

Army Materiel Systems Analysis Activity:
AMSAA 2011-2012 Senior Project - Army Exhaust Brake

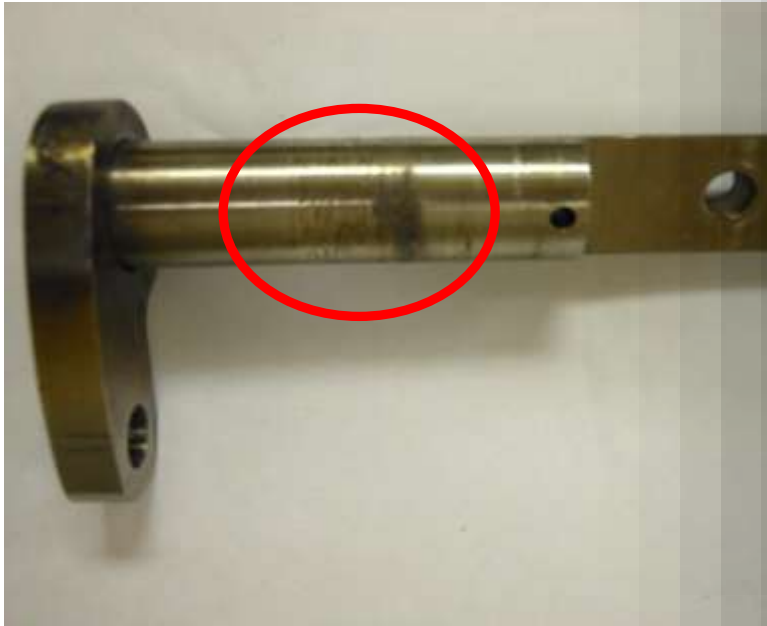
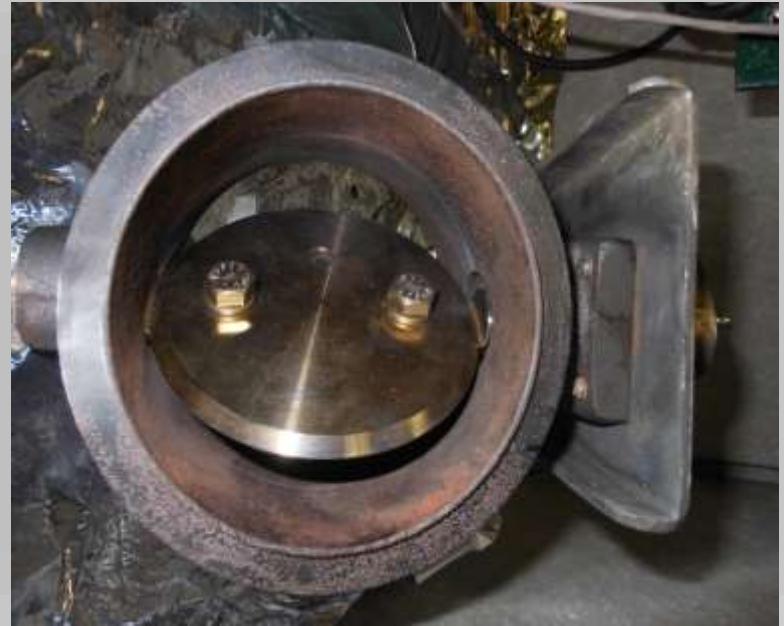
Cyclic Test Cont.

- First test lead to galling failure

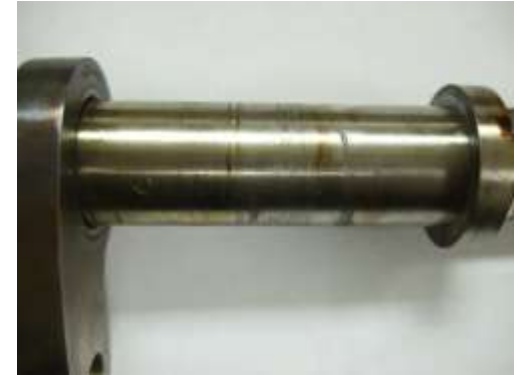
2nd Cyclic Test

- Second cyclic test
 - No failure in over 1500 actuations
 - Minor galling
 - 2D finite difference model verified

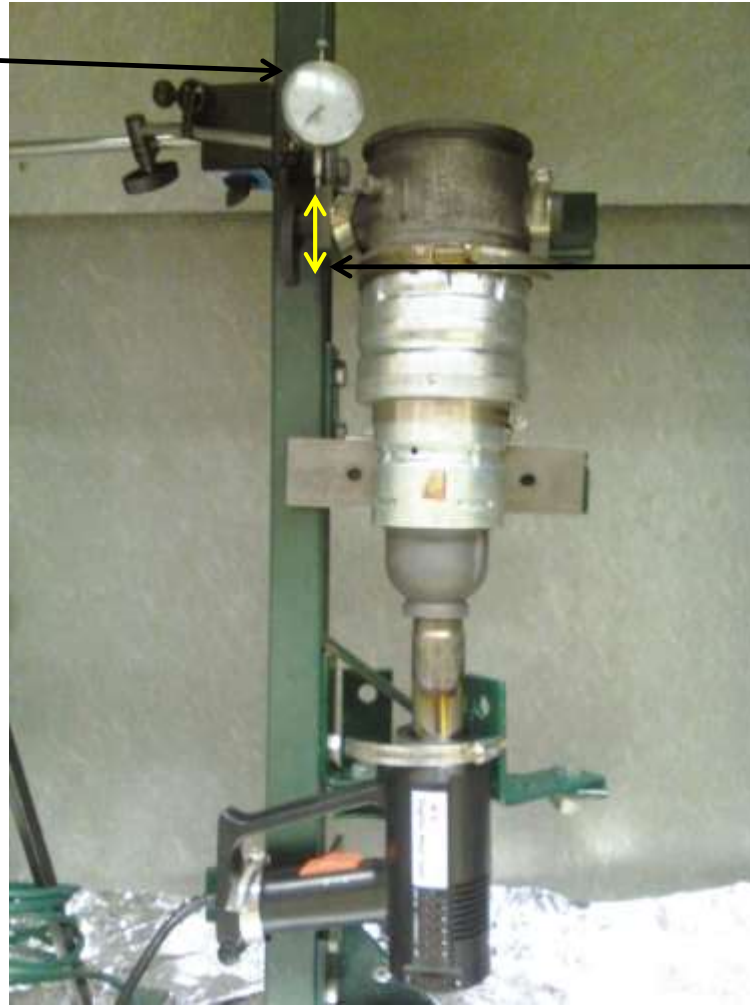
Bearing Clearance Test

Dial Indicator

Radial Clearance measurement

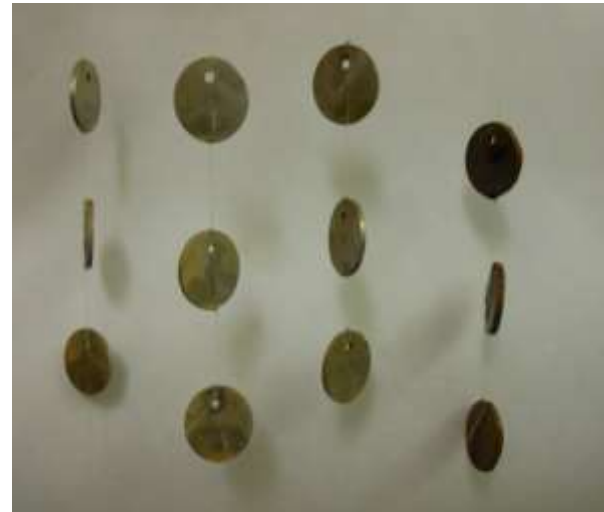
Corrosion Testing

- Primary and secondary mode of failure in original brake negated

Material	Corrosion Rate (mm/year)
Nitronic 60	0
304	370
410	155
1018	14075

$$\text{corrosion rate} = \frac{W}{A \times T \times D}$$
