REPORT ON RECONNAISSANCE
OF A PORTION
OF
HIGHLAND ESTATES SUBDIVISION (FIRST FILING)
GILLETTE, WYOMING

Environmental Geology Section

Geological Survey of Wyoming

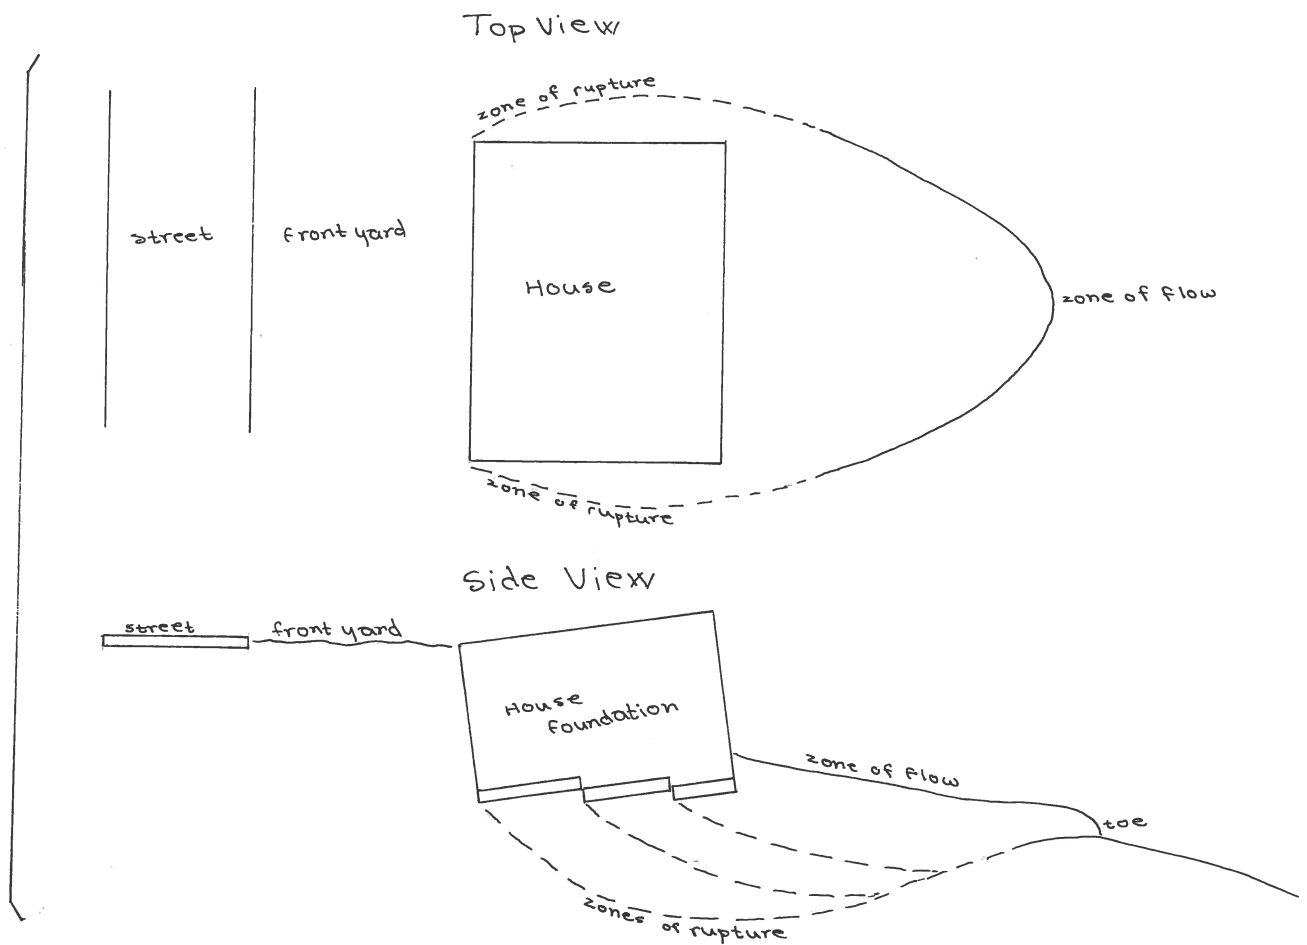
Slumped position

The result of the scenario for Slater's home is that the house would not only tilt forward, but also sag at it's sides. This could be due to minor moisture differences in the fill, with the more moist fill under the front and sides of the house compacting to a greater degree than the fill under the rear.
